DIGESTER 5 INTERIOR COATING PROJECT

BID #13/14-018 – PWP# WA-2014-112

TMWRF- Interior Coating Inspection Digester No. 5

TO: Mike Damoth/CH2M HILL
COPIES: Matt Larsen/Carollo Engineers
FROM: Rod Jackson
DATE: November 10, 2006

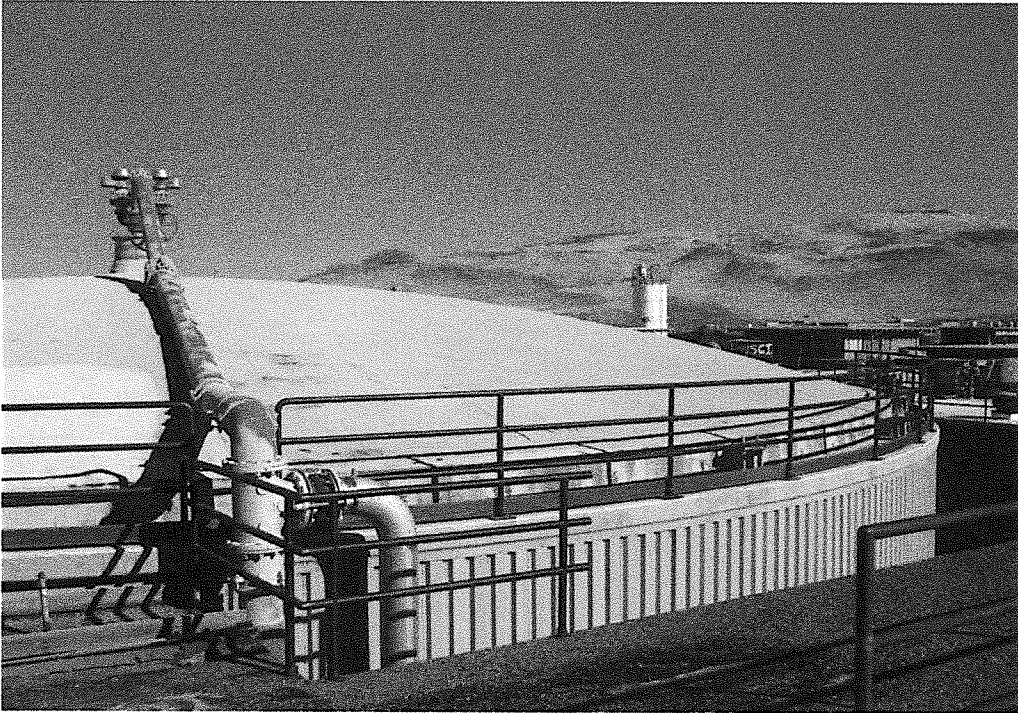
We found that some details of the cover construction did not appear to match the record drawings. The cover connection to the tank wall is not constructed as shown on drawing M-17, Detail 2. The configuration of the connection is shown in Photos 1 and 2. The connections consist of steel beams held in place by brackets on the top of the wall. A steel angle covers the joint between the tank wall and the side wall of the cover.

Photo 1: Overview of digester cover. Gray surface is coated polyurethane foam insulation. Edge of steel cover is visible behind handrail. Two cover connection brackets are visible at photo right center.

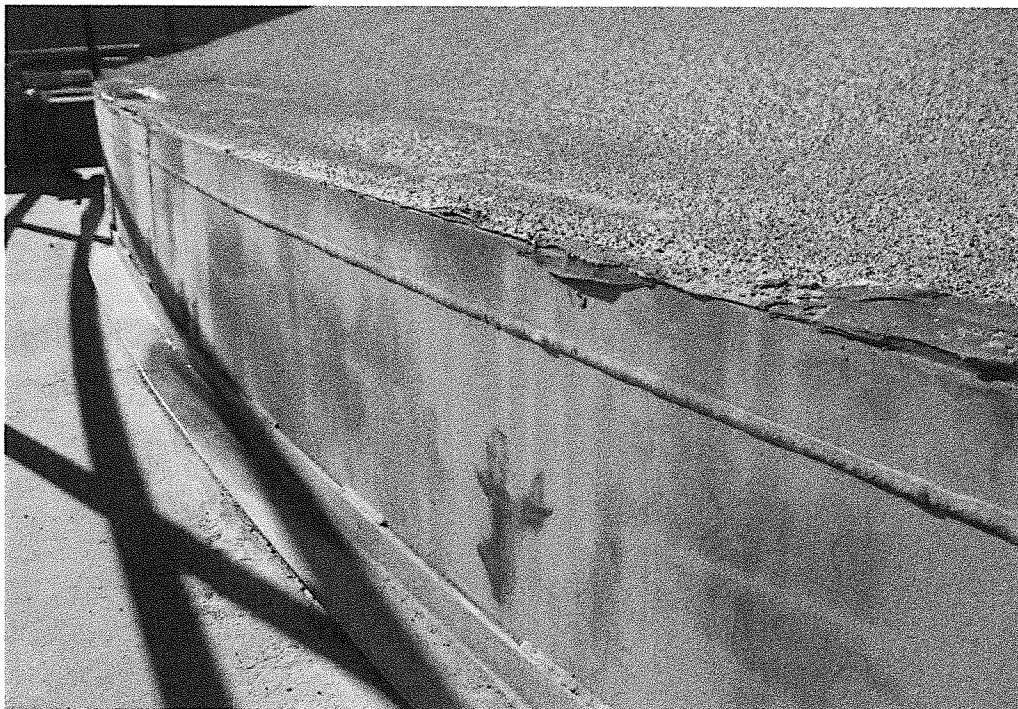
According to the drawings, the seal between the skirt portion of the steel cover and the concrete tank wall was constructed with hot coal tar pitch and oakum caulking in the annular space around the cover. The seal is hidden by the steel angle on top of the cover, and we could not get close enough to see the lower part of the seal from inside the tank. There was no sign of leakage around the top perimeter of the cover, so whatever method of sealing that was actually used has apparently been successful.

Photo 2: Skirt' area of cover. Top of concrete tank wall is at photo lower left. Cover includes coated foam insulation, sidewall, and steel angle. Connection bracket is visible at far top left of photo.

The outdoor exposed portion of the skirt and connection brackets should be abrasive blasted and recoated with an epoxy/urethane system for sunlight exposure. The portion of the skirt below the top of the tank wall cannot be recoated with the cover in place. However, it is quite possible that the coal tar pitch used for the digester seal is intact and providing corrosion protection for the steel. A close inspection should be made when the raised floor is erected in the tank. Assuming that the seal is in good condition, it should be covered during the recoating project to protect the soft seal from the harsh effects of abrasive blasting.

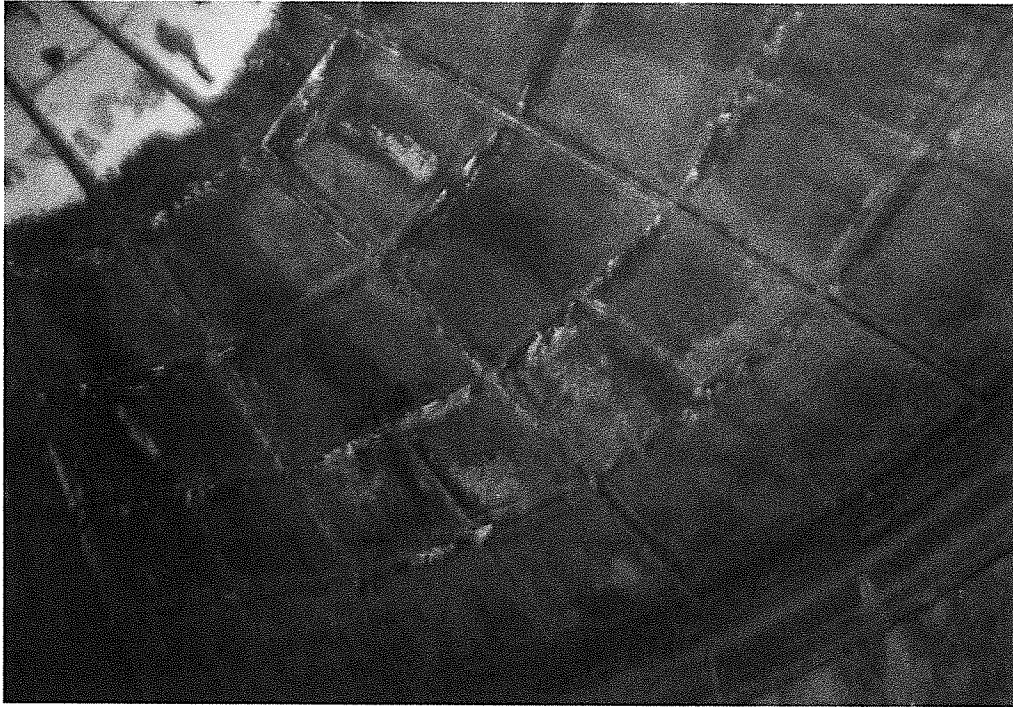
The interior coating on the digester cover does not appear to be Sikagard 62 epoxy. This conclusion is based primarily on the fact that the coating is uniformly black in color rather than the gray color of Sikagard 62. The black coating is probably coal tar epoxy unless the Sikagard 62 was applied and simply turned black in service.

1. The coating has deteriorated at connections between the steel framing members. Virtually all connections show some rust, but none of the framing members have buckled or sagged.
2. Corrosion has occurred at the interfaces between the steel plates and the steel framing members. This indicates that the steel plates may not be welded to the top of the framework, thereby allowing corrosion occur at unpainted areas along the mating surfaces between the plates and framework.
3. The coating has deteriorated on the steel plates in a band about 7 to 15 feet from the wall of the tank. Rust is evident on the plates within this band. The steel surface appears to be pitted.

Although deterioration of the coating and rusting of the steel are evident in the areas noted above, it does not appear that corrosion has caused extensive damage. The steel plates appear to be free of perforations, and the framing members appear to be straight and intact.

Photo 3: Typical condition of cover interior. Center of cover is at photo upper left.
Black areas appear to be coated with coal tar epoxy.
Orange areas are rusty steel exposed at areas of deteriorated coating.

The interior coating on the steel cover of Digester No. 5 has deteriorated and allowed corrosion of the steel to occur in localized areas. The large number and wide distribution of these deteriorated areas across the cover precludes the use of spot repairs to restore the coating. Therefore, it is reasonable to plan to recoat the entire interior of the cover.

A recoating project for Digester No. 5 would require erection of a raised floor in the tank for access to the cover. An initial abrasive blast cleaning would be done to remove the existing coating and allow close inspection for corrosion damage. After any indicated steel repairs are made, a second abrasive blast surface cleaning would be done to prepare the steel surfaces for coating. A new epoxy coating would be installed consistent with current industry practices for digesters.

The interior framing of the cover has many angles and edges that should be stripe-coated to improve durability, because these are usually the areas where the coating deteriorates first. If the steel plates are not welded to the structural members, it would be advisable to try to temporarily lift the plates a few inches off the members to allow blasting and coating of the interfaces.

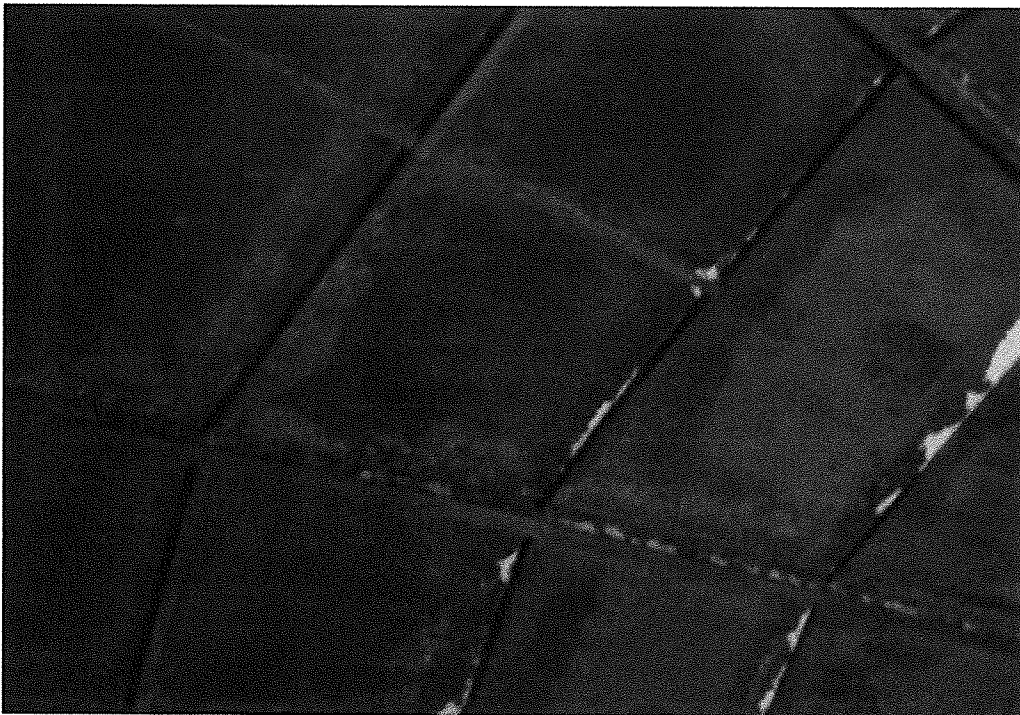
Photo 4: Typical appearance of steel framing showing rust (corrosion products) along edges.
White areas are deposits from digester operation.

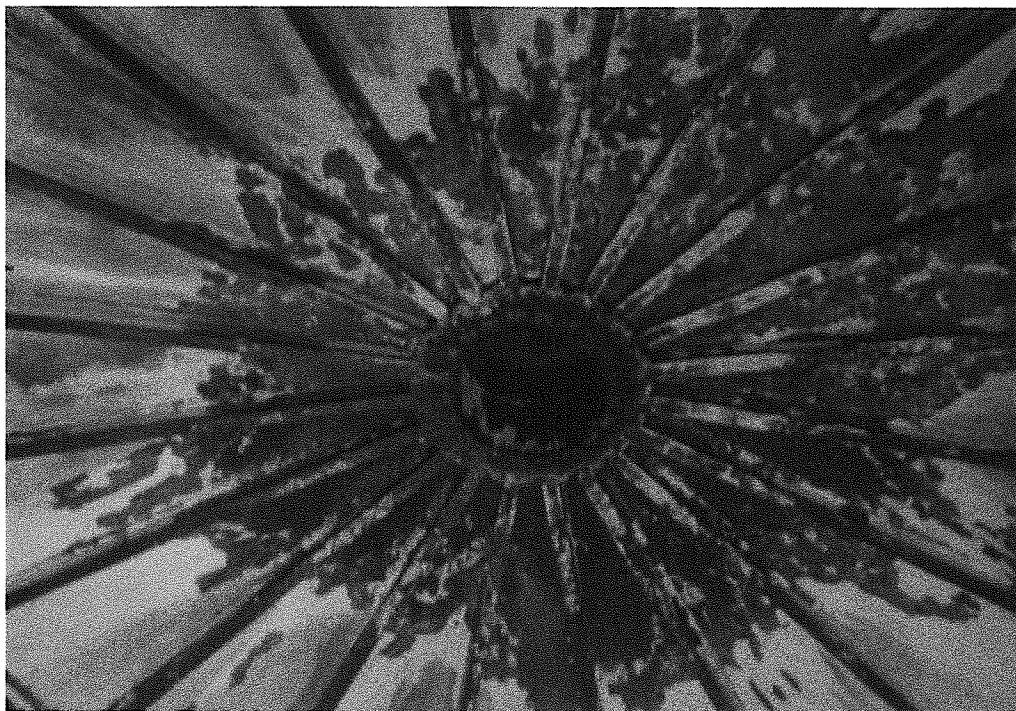
The center portion of the cover is covered by white deposits and appears to be in better condition than the rest of the cover, with the exception of rust at the bolted connections of the framing members to the center ring. All other framing connections appear to be welded, although it is difficult to tell for certain from floor level.

Photo 5: Center portion of cover as viewed from floor of digester.
White areas are deposits from digester operation.
Orange-brown areas are rusted steel, including connection bolts at center ring.

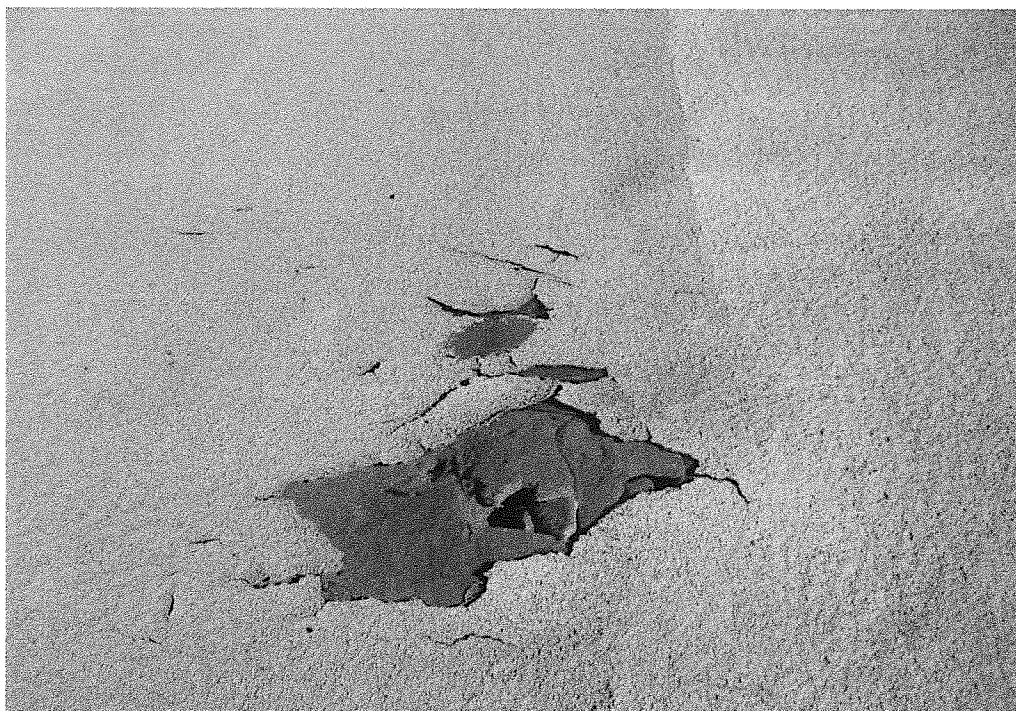
There are approximately 25 locations on the top of the cover where the coating over the polyurethane foam insulation has been damaged or deteriorated. These areas should be

repaired to prevent water from entering the insulation and contacting the steel. Trapped moisture could cause corrosion on the top of the cover.

Photo 6: Typical damaged area in polyurethane foam insulation on top of cover.
Area shown is approximately 1 foot square. About 25 such areas exist.

The damaged coating for the polyurethane foam insulation on the exterior of the cover should also be repaired to prevent the insulation from becoming wet and causing corrosion of the underlying steel.
