ADDENDUM #2

306 10th STREET AFFORDABLE HOUSING DEVELOPMENT PROJECT

**RE: OSHA LEAD DEMOLITION SURVEY
Single Family Residence Demolition
306 10th Street Sparks, NV 89431**

RE: ASBESTOS DEMOLITION SURVEY
Single Family Residence
306 10th Street Sparks, NV 89431

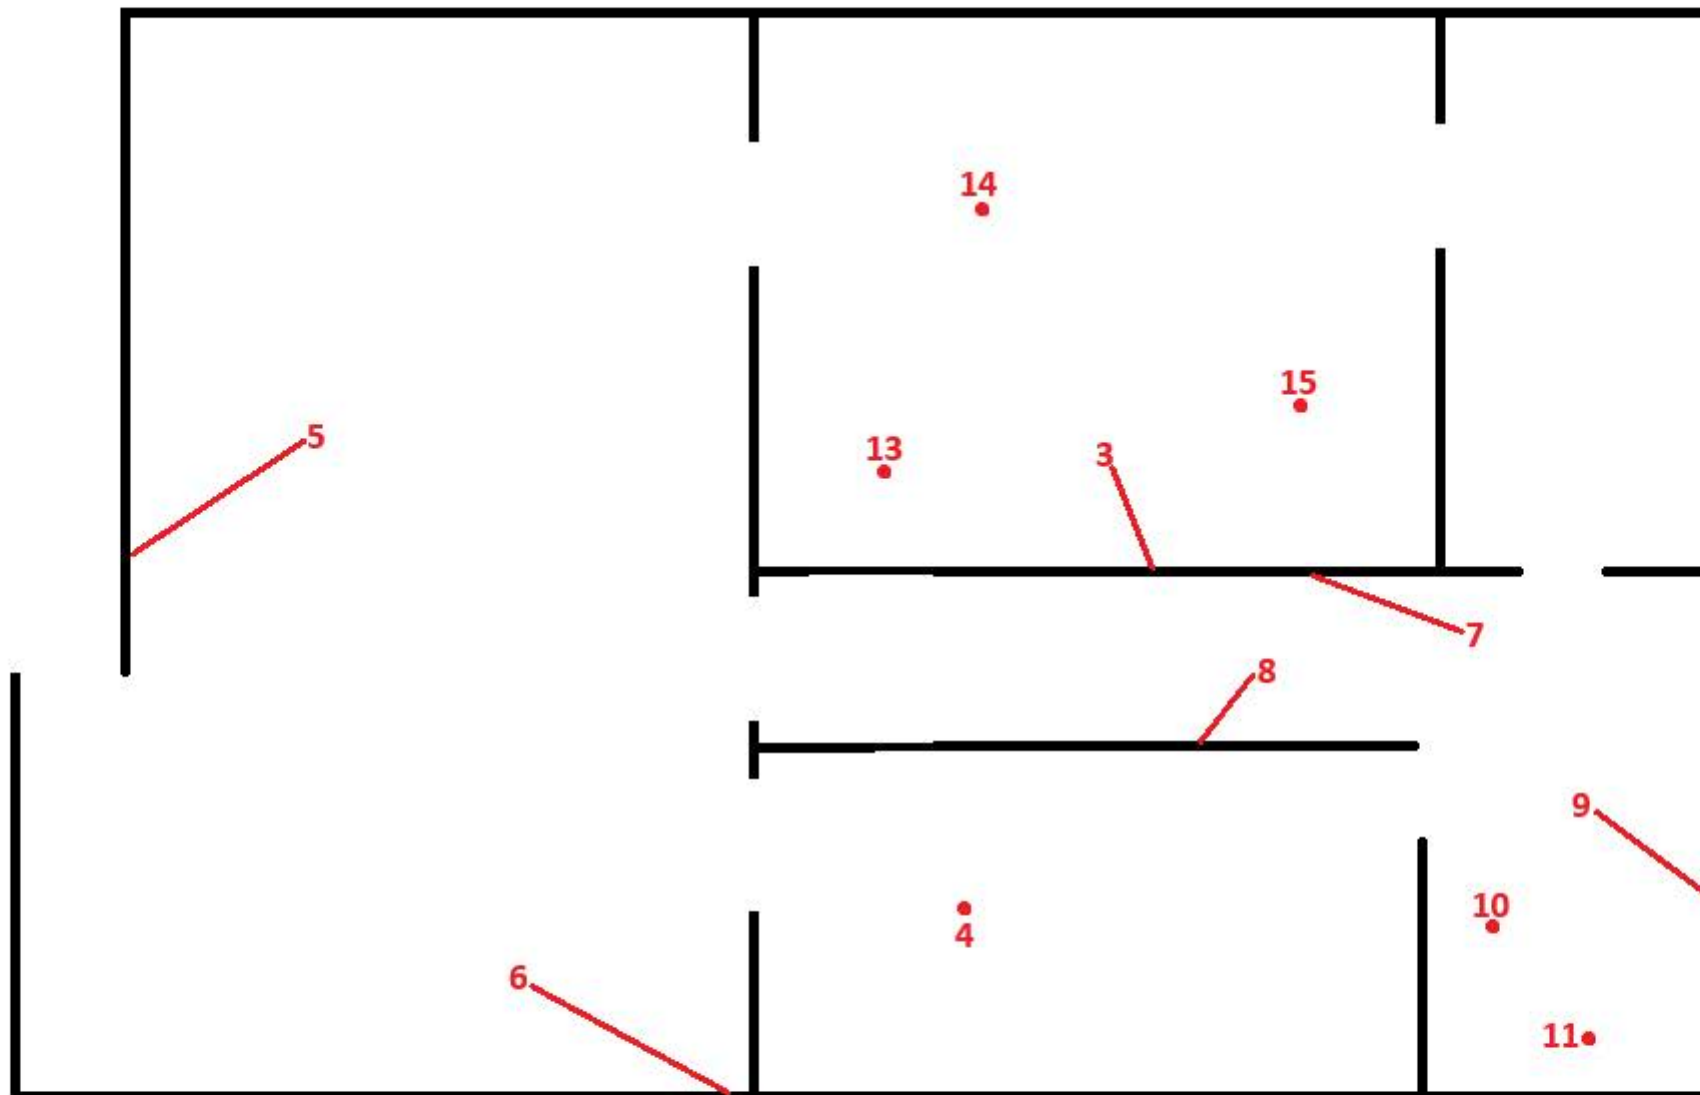
ASBESTOS SAMPLE LOCATION SKETCH

First Floor

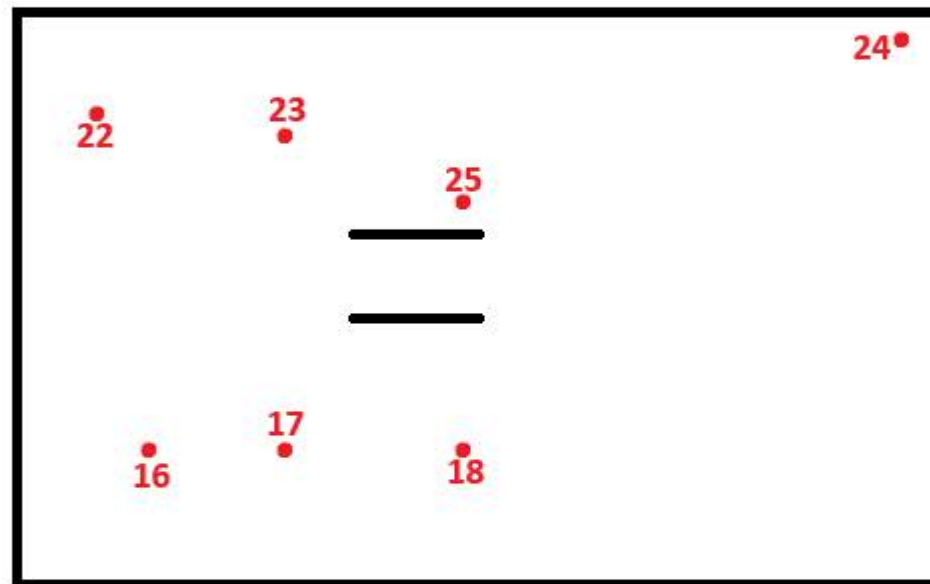
ACM Summary Data			
Material Description	Material Location	Sample Number & Asbestos Content	*Friability
Duct Wrap	Basement on HVAC System	24173-16 40% Chrysotile	F
*Note: Friable (F) – because the material will easily release asbestos fibers with renovation or demolition action and therefore Friable materials are Regulated ACM for disturbance and waste handling; Potentially Friable (PF) - because the materials may release asbestos fibers under standard renovation or demolition actions, so determination of removal procedures and waste handling is required by a professional / licensed asbestos contractor or consultant; Non-Friable (NF) - because standard renovation and demolition action are proven to not release elevated levels of asbestos fibers.

In conclusion, the ACM detected in this survey was the Duct Wrap that is Friable. We recommend that the Duct Wrap be removed in a Class 1 Containment by a licensed abatement contractor, per NV and EPA/NNPH asbestos regulation requirements. We further recommend that clearance inspection and air testing of the abatement work be conducted by an independent state licensed asbestos consultant to confirm the work is complete prior to demolition, per applicable asbestos regulations.
