QUOTATION REQUEST DIGESTER 2 COVER REHABILITATION PROJECT

Quotation Request No. 1

Title: Structural Steel Repairs

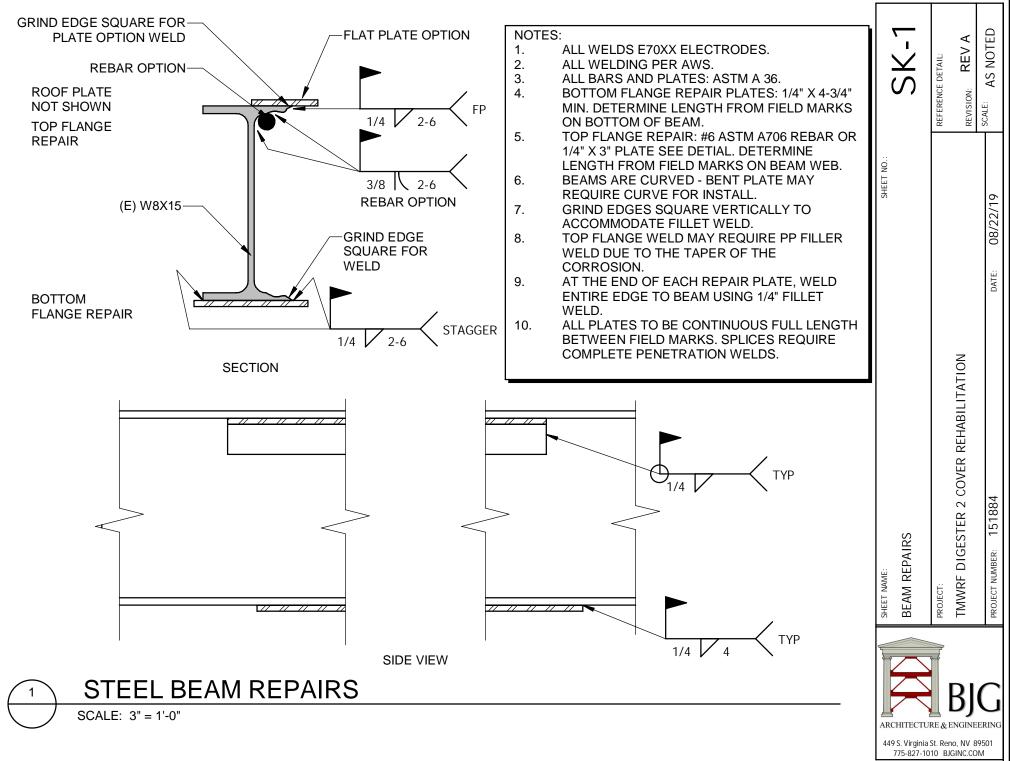
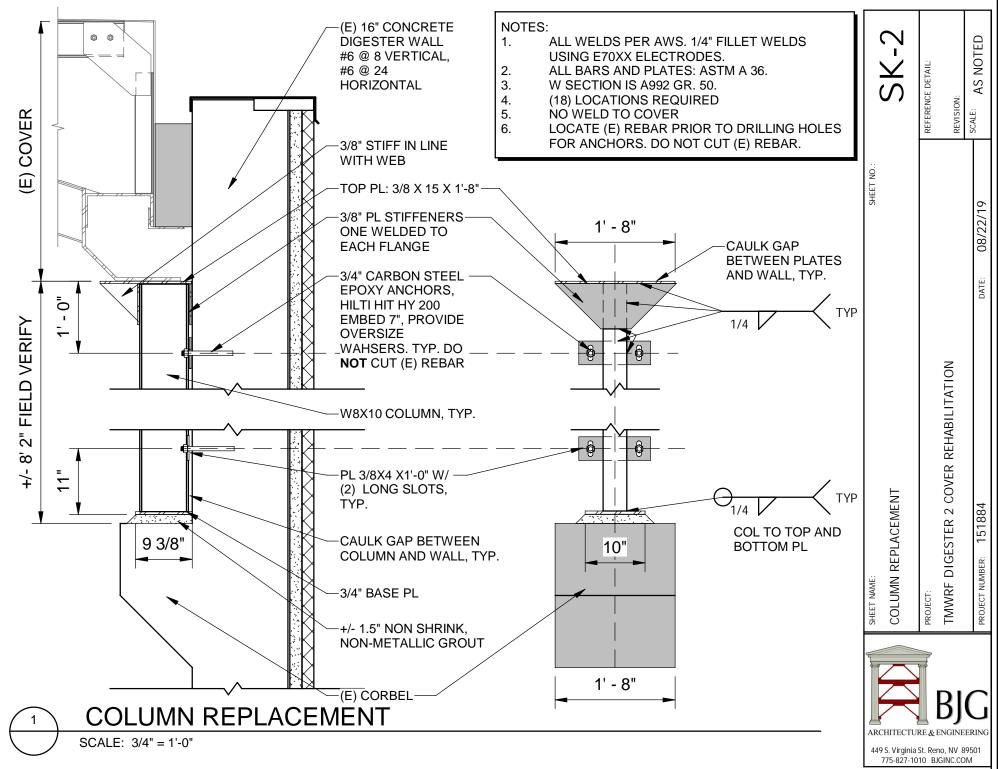
Steel columns and beams within the Digester have deteriorated due to corrosion and need to be repaired.

- 1. Replace all beam bolts with A307 bolts to match the existing bolts size and length throughout the Digester cover.
- 2. Perform Beam Repairs as marked in chalk in the field. Top chord repairs were marked on the beam web on the side to be repaired. Bottom flange repairs were marked on the bottom of the beam. Perform repairs as indicated in drawing SK-1.

- 3. Install 18 new columns to match the existing columns. The new columns shall be installed on the existing empty corbels. A drawing of the existing columns, detail A in drawing 30-S-B, is included for reference from the structural engineer. Columns shall match the existing columns, except the existing corbels shall not be drilled into. Delete the anchors in the base of the column. Install grout between the column base and corbel. Scan the concrete wall to locate existing rebar prior to drilling into the existing concrete wall. Rebar shall not be cut to install concrete anchors. Each column has 6 horizontal concrete anchors.

- 4. New columns shall be coated with System 1, 100% solids elastomeric polyurethane, or System 2, epoxy per specification 09800. If system 1 is chosen it should be applied prior to installing the columns.

- 5. Existing column holes due to corrosion shall be caulked, coated with system 2 in specification 09800, and remain in place.
- 6. Coat all anchors after installation.
