**STRUCTURAL SECTION AND
SUBGRADE INVESTIGATION
2026 DRAINAGE AND ROADWAY
REHABILITATION PROJECT
L STREET FROM PYRAMID WAY TO STANFORD WAY
AND 5TH STREET FROM L STREET TO GREENBRAE DRIVE
SPARKS, NEVADA**

**NOVEMBER 2025
FILE: 3630**

**RE: Structural Section and Subgrade Investigation
2026 Drainage and Roadway Rehabilitation Project
L Street from Pyramid Way to Stanford Way
and 5th Street from L Street to Greenbrae Drive
Sparks, Nevada**

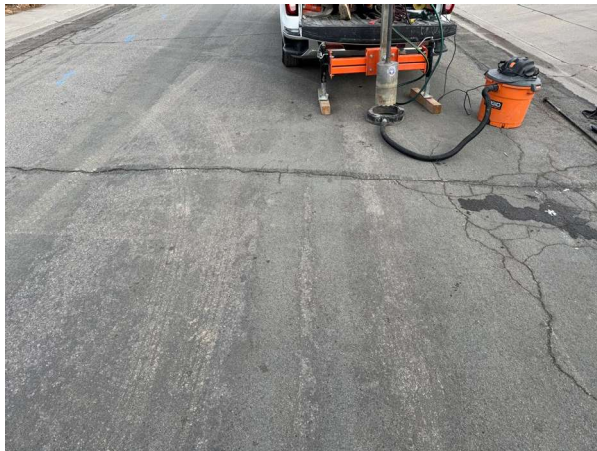
Photograph 1: Pavement Condition at C-24-06

- Regularly spaced low to high severity transverse (thermal) cracking
- Longitudinal cracking
- Alligator cracking
- Block cracking
- Extensive areas of the roadway show large areas of medium severity fatigue cracking.
- Minor and major patching is observed, likely due to utility work.
- Evidence of previous crack sealant and slurry seal applications. The Crack sealant appears old and likely past its functional life.

Photographs 1 and 2 show the typical pavement condition on 5th Street while Photographs 3 through 8 show typical pavement conditions at several locations across the L Street segment.

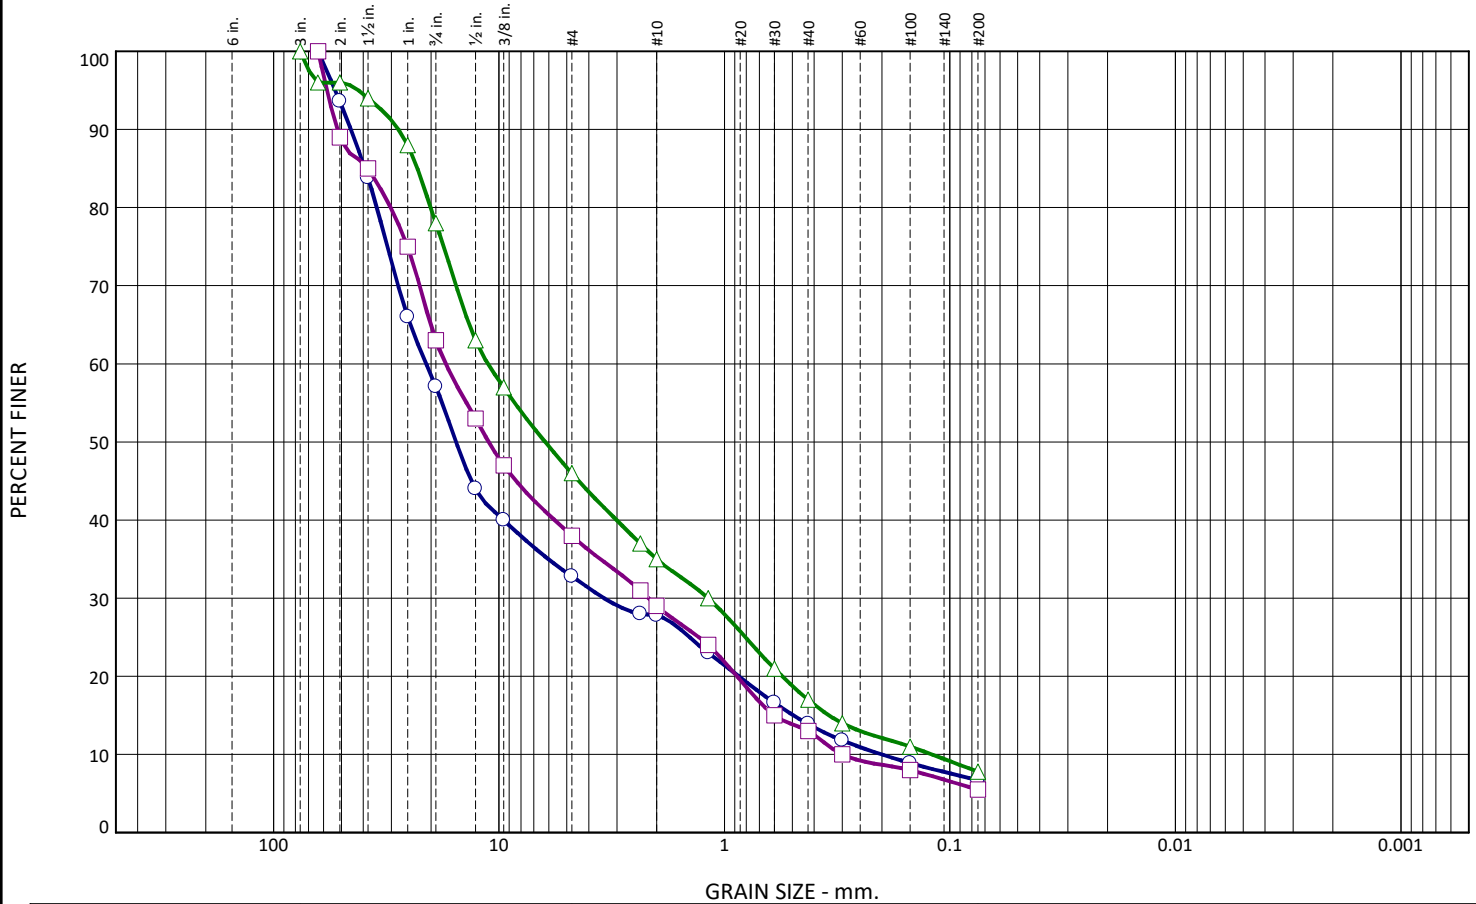
Particle Size Distribution Report

% +3"	% Gravel		% Sand			% Fines			
		Coarse	Fine	Coarse	Medium	Fine	Silt	Clay		
○	0.0	42.9	24.3	5.0	13.9	7.2	6.7			
□	0.0	37.0	25.0	9.0	16.0	7.5	5.5			
△	0.0	22.0	32.0	11.0	18.0	9.2	7.8			
×	LL	PL	D ₈₅	D ₆₀	D ₅₀	D ₃₀	D ₁₅	D ₁₀	C _c	C _u
○	23	18	39.3149	20.9980	15.5014	3.4173	0.4937	0.2005	2.77	104.71
□	NV	NP	38.1000	17.2279	11.1071	2.1735	0.6000	0.3000	0.91	57.43
△	23	19	23.0001	11.2116	6.2396	1.1800	0.3431	0.1204	1.03	93.12

Material Description	Test Date	USCS	NM
○ well-graded gravel with silty clay and sand		GW-GC	
□ poorly graded gravel with silt and sand		GP-GM	
△ well-graded gravel with silty clay and sand		GW-GC

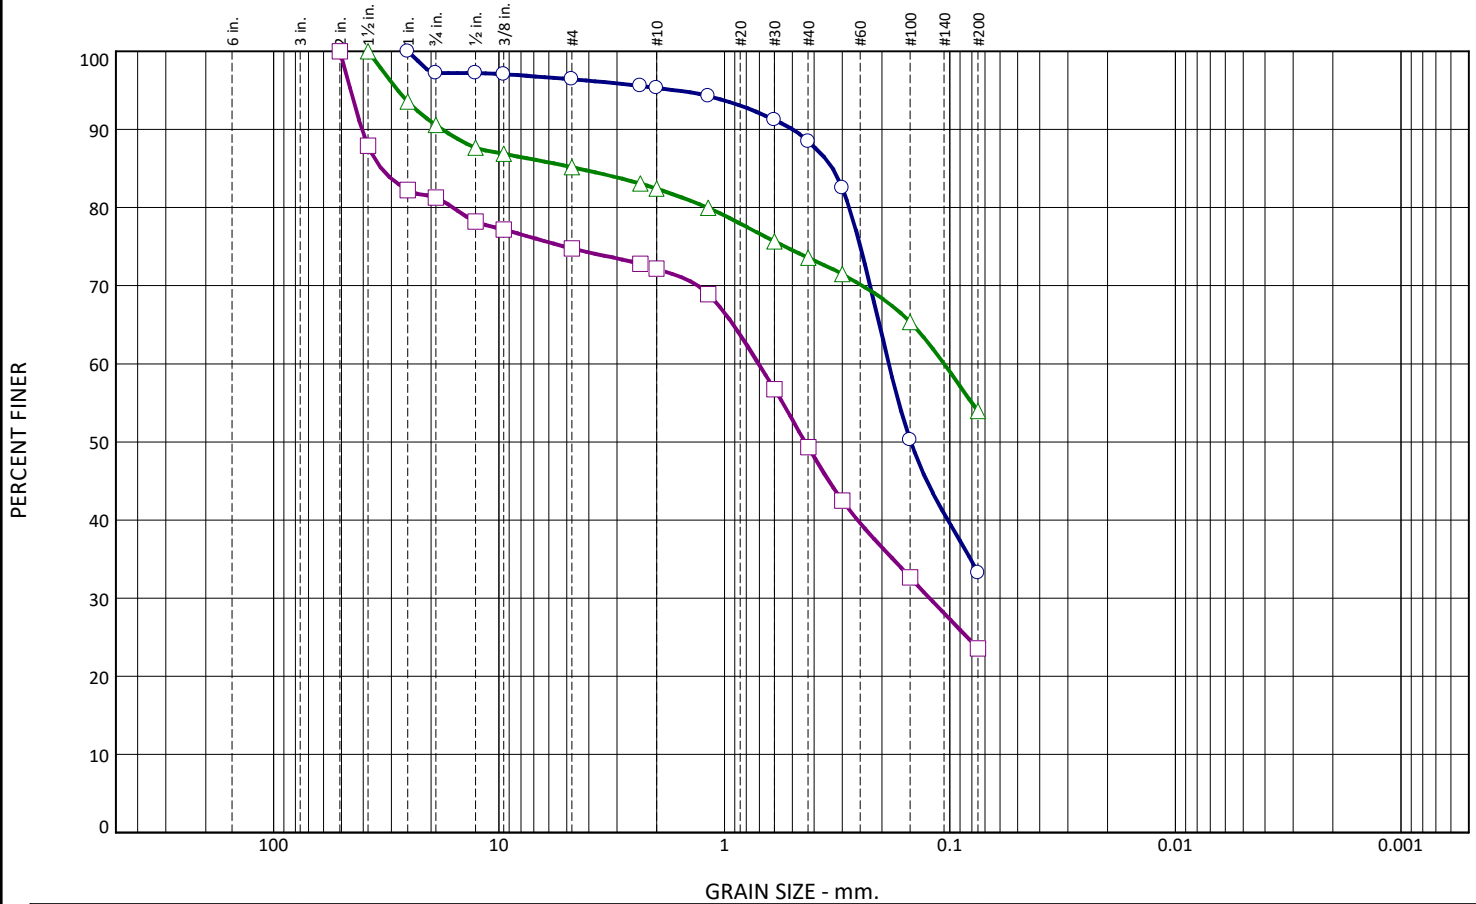
Particle Size Distribution Report

% +3"	% Gravel		% Sand			% Fines
		Coarse	Fine	Coarse	Medium	Fine	
○	0.0	2.8	0.8	1.1	6.8	55.3	33.2
□	0.0	18.7	6.5	2.6	22.9	25.7	23.6
△	0.0	9.4	5.4	2.8	8.8	19.6	54.0

LL	PL	D ₈₅	D ₆₀	D ₅₀	D ₃₀	D ₁₅	D ₁₀	C _c	C _u
○	28	21	0.3305	0.1866	0.1489					
□	22	18	33.2552	0.7058	0.4387	0.1229				
△	36	21	4.4589	0.1061

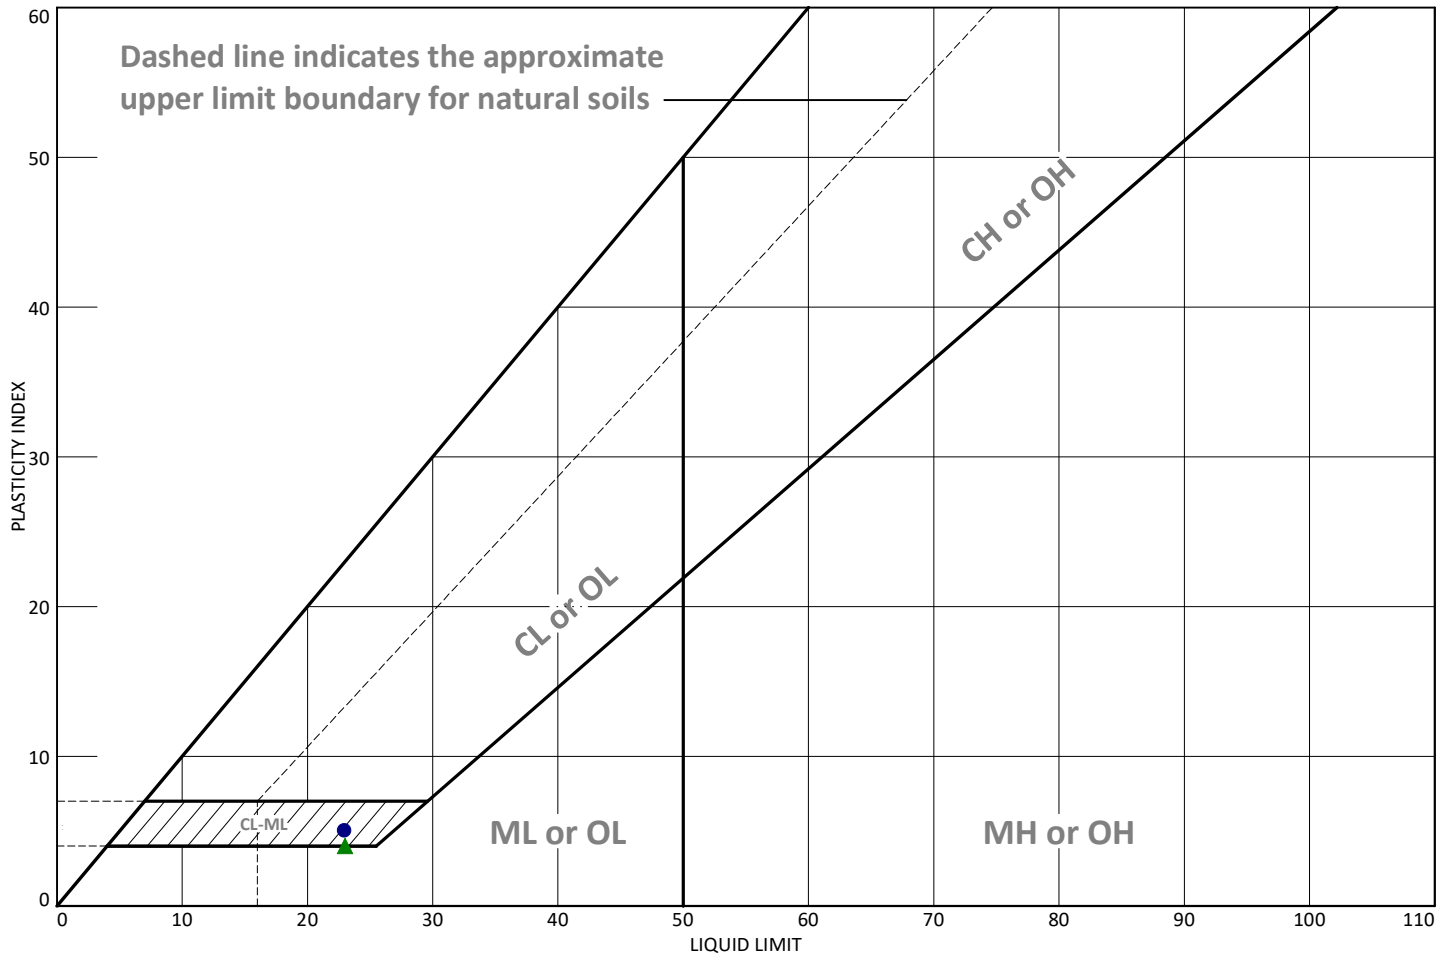
LIQUID AND PLASTIC LIMITS TEST REPORT

MATERIAL DESCRIPTION	LL	PL	PI	%<#40	%<#200	USCS
●	well-graded gravel with silty clay and sand	23	18	5	13.9	6.7	GW-GC
■	poorly graded gravel with silt and sand	NV	NP	NP	13.0	5.5	GP-GM
▲	well-graded gravel with siltyclay and sand	23	19	4	17.0	7.8	GW-GC

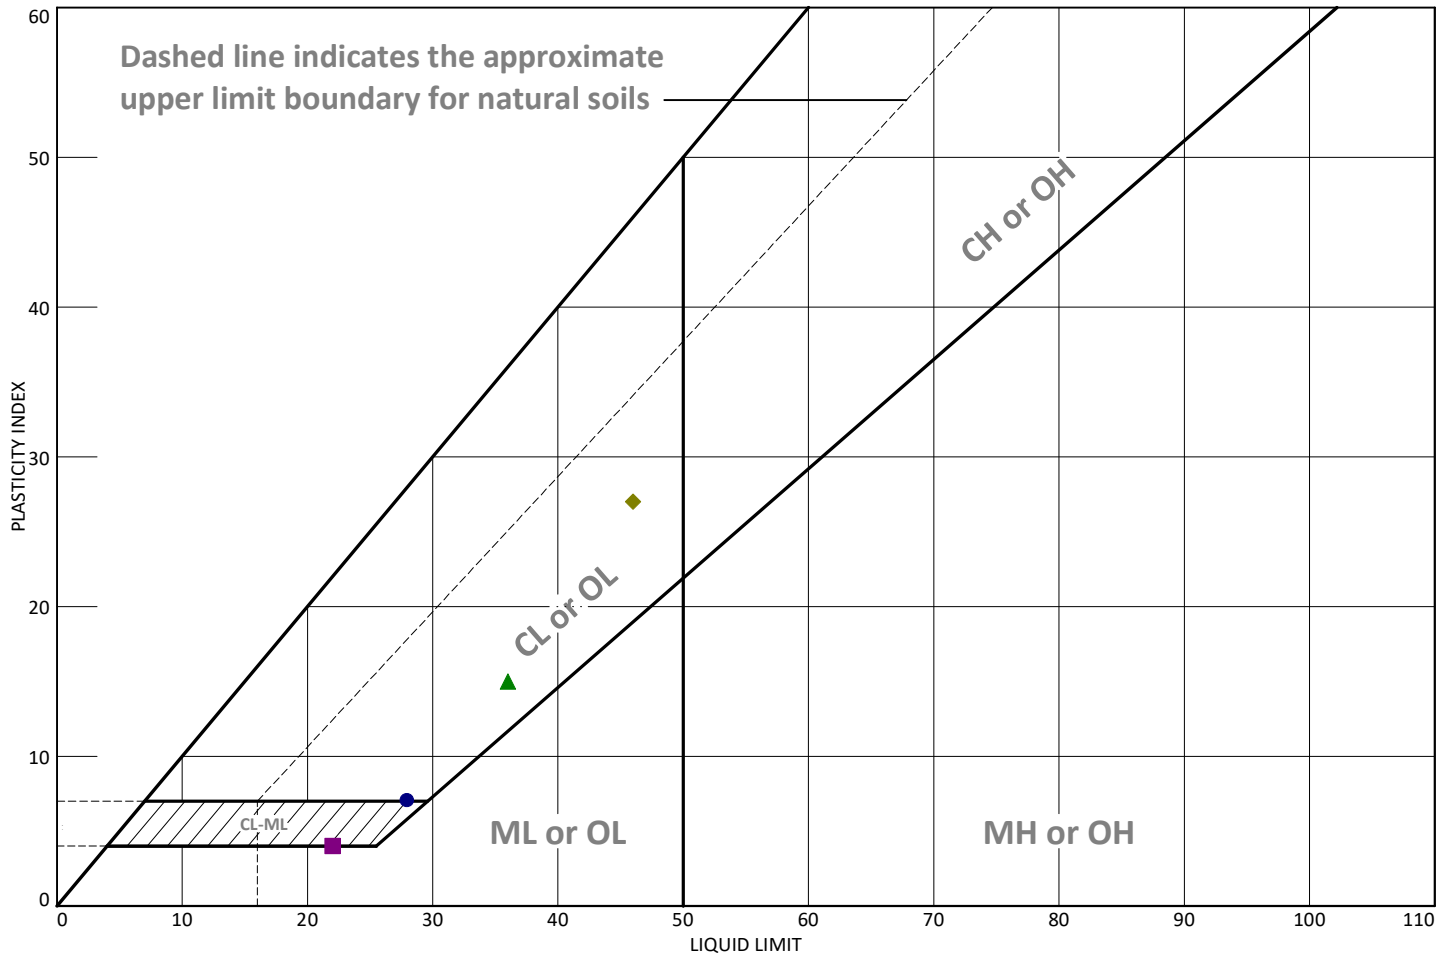
LIQUID AND PLASTIC LIMITS TEST REPORT

MATERIAL DESCRIPTION	LL	PL	PI	%<#40	%<#200	USCS
●	silty, clayey sand	28	21	7	88.5	33.2	SC-SM
■	silty, clayey sand with gravel	22	18	4	49.3	23.6	SC-SM
▲	sandy lean clay	36	21	15	73.6	54.0	CL
◆	sandy lean clay	46	19	27	76.3	62.3	CL

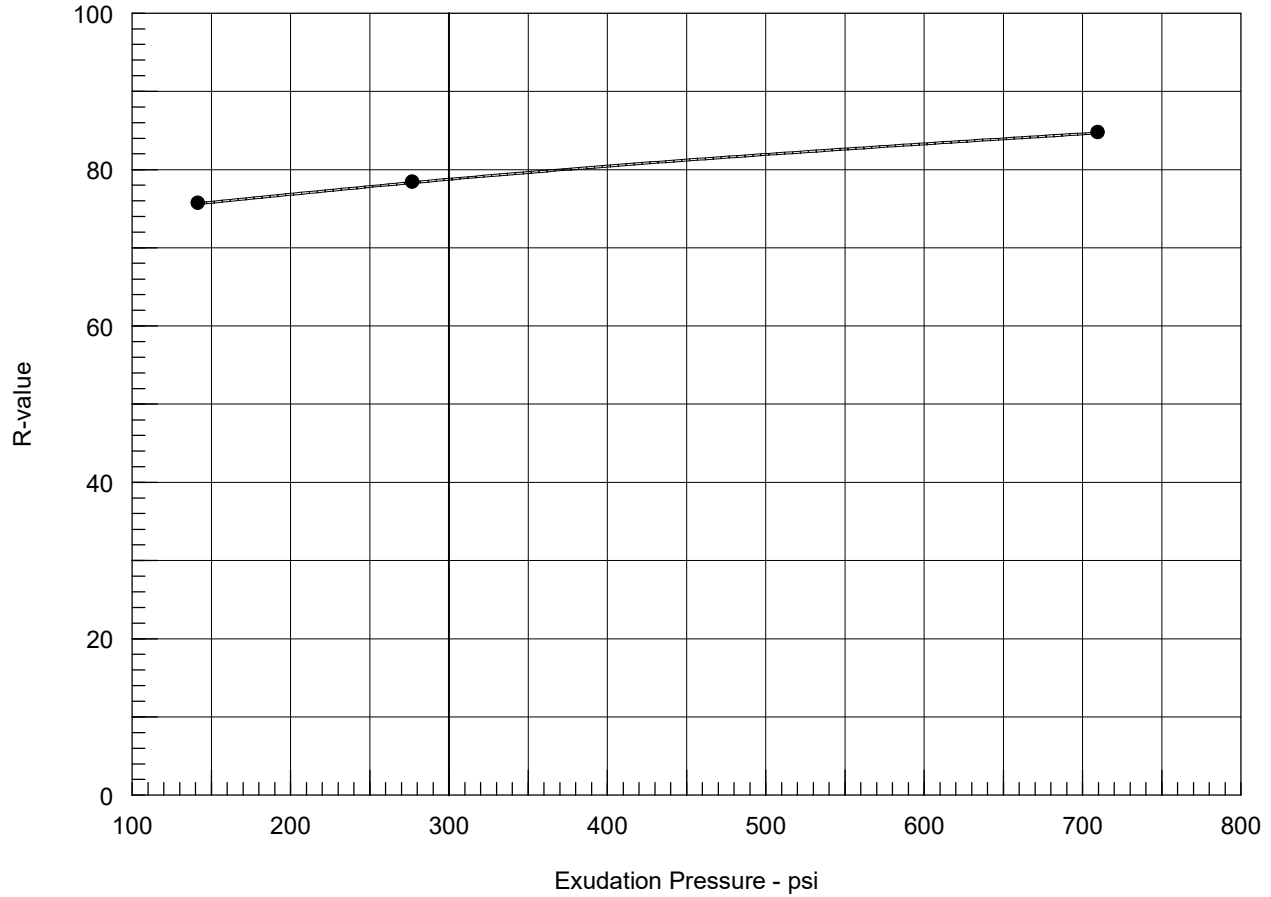
R-VALUE TEST REPORT

Resistance R-Value and Expansion Pressure - ASTM D2844

No.	Compact. Pressure psi	Density pcf	Moist. %	Expansion Pressure psi	Horizontal Press. psi @ 160 psi	Sample Height in.	Exud. Pressure psi	R Value	R Value Corr.
1	250	140.4	9.8	0.00	22	2.45	142	76	76
2	350	142.7	7.6	0.00	13	2.50	710	85	85
3	350	141.4	8.6	0.00	19	2.50	277	78	78

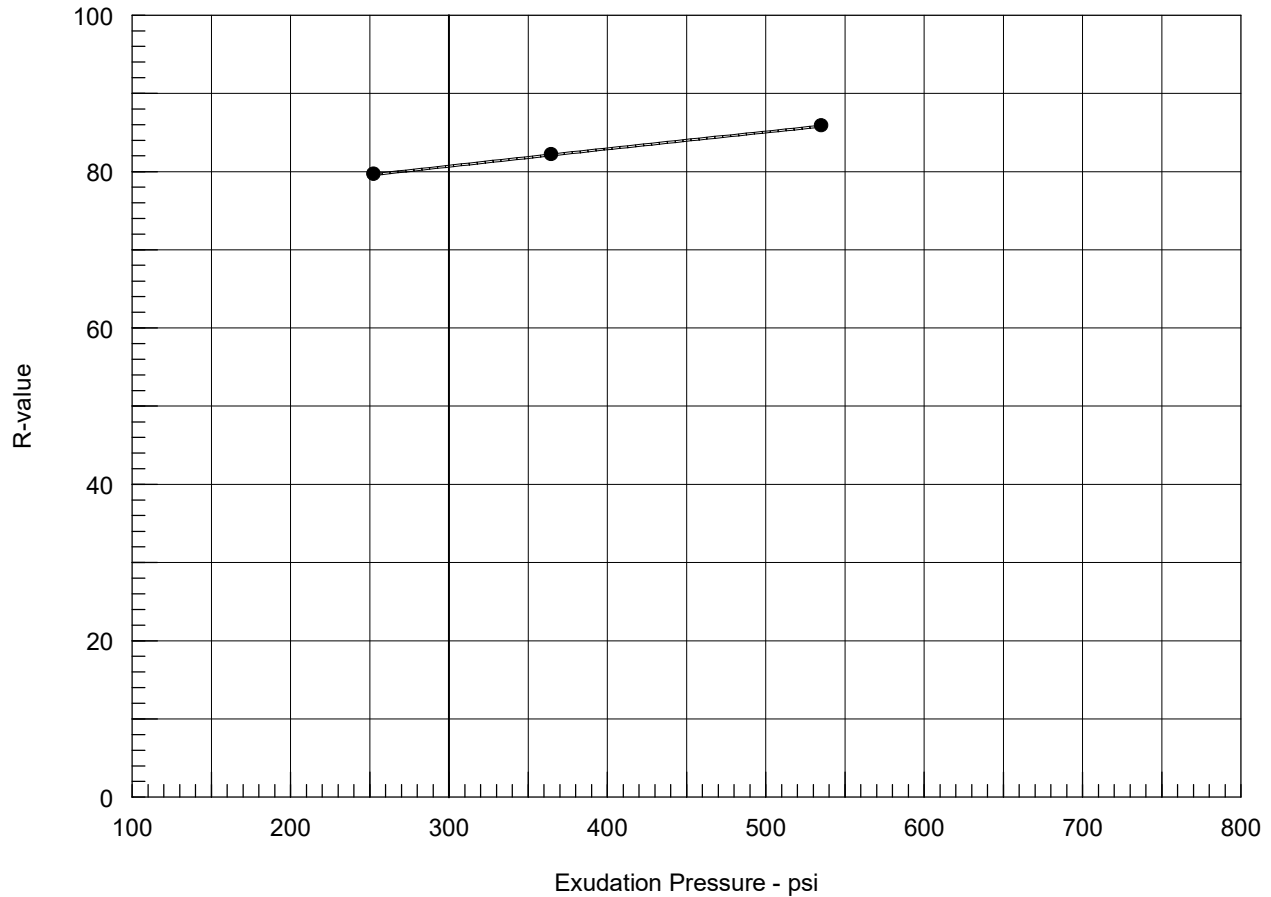
R-VALUE TEST REPORT

Resistance R-Value and Expansion Pressure - ASTM D2844

No.	Compact. Pressure psi	Density pcf	Moist. %	Expansion Pressure psi	Horizontal Press. psi @ 160 psi	Sample Height in.	Exud. Pressure psi	R Value	R Value Corr.
1	350	134.6	8.4	0.00	14	2.45	535	86	86
2	250	132.0	10.0	0.00	20	2.50	253	80	80
3	300	133.7	9.4	0.00	18	2.50	365	82	82
